# REMEDIATION INVESTIGATION AND FEASIBILITY STUDY FOR “INPLACE” MINE WASTE INFLUENCED GROVE GULCH, BUTTE, MT

REMEDIATION INVESTIGATION AND FEASIBILITY STUDY FOR “IN-  
PLACE” MINE WASTE INFLUENCED GROVE GULCH, BUTTE, MT

Masters of Science in Environmental Engineering

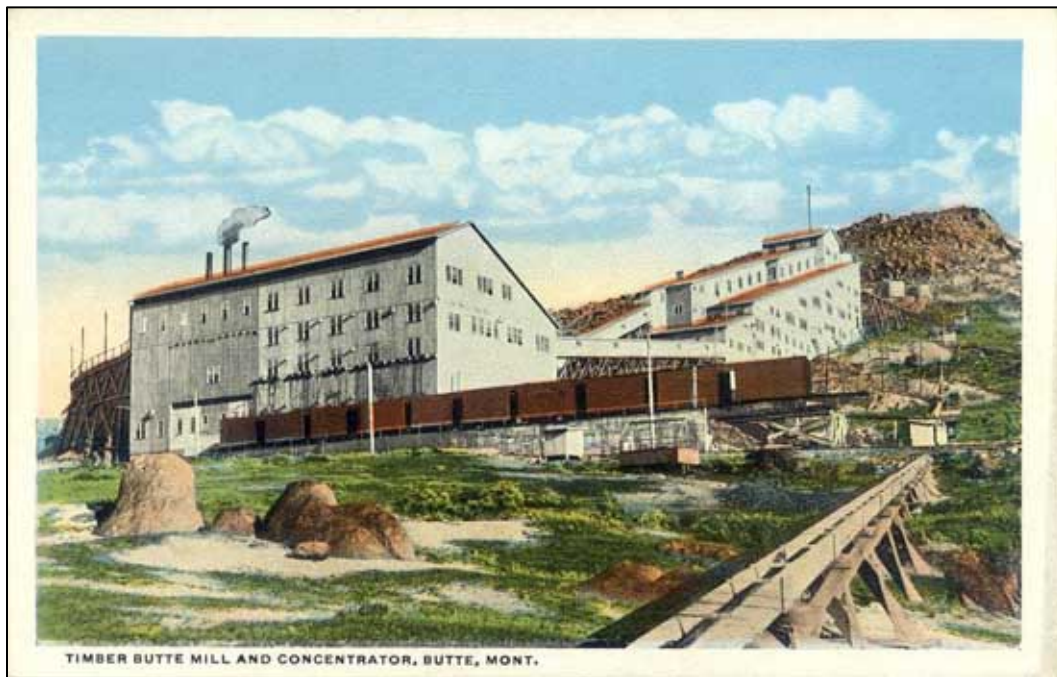
**Figure 2: Timber Butte Zinc Mill** (USGW Archives, n.d.)

The Timber Butte Zinc Mill was built in 1914 by William Clark and was located along the northwestern slope of Timber Butte Mountain, which lies roughly two miles south of Butte (Figure 2). The Timber Butte Zinc Mill processed ore from the nearby Elm Orlu Mine (current the Berkeley Pit location) and the then state of the art mill processed roughly 450 tons of ore per day and utilized the latest metallurgical technical advancement for its time. Early assays records from the Elm Orlu mine showed zinc concentrations up to 18% along with other metals such as copper, silver, gold, and lead. Following the death of William Clark in 1925, the Timber Butte Zinc Mill was acquired by the Anaconda Company and ran intermittently until after World War II when it was demolished in 1949 (OXO Foundation, 1973).

With high metal concentrate and throughput, William Clark's zinc mill also produced a considerable amount of tailings waste. During the life of the zinc mill, roughly a million cubic yards of tailings were impounded along the Grove Gulch watershed (Hydrometrics, 1983).

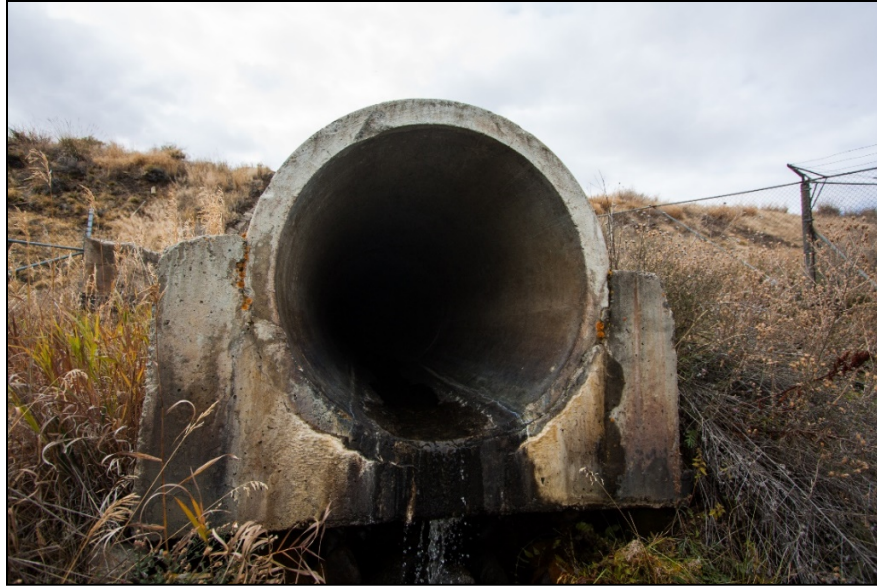
**Figure 3: Current 42-inch concrete culvert connecting upper and lower Grove Gulch**

The Clark Tailings, generated as a byproduct of William Clark's Timber Butte Zinc Mill, occupied an area roughly 62 acres. Over a period of 35 years roughly one million cubic yards of heavy metal-laden tailings were produced and are currently impounded along the Grove Gulch. Before production of the tailings, a combination vitrified tile and wood stave pipe was installed to transport the Grove Gulch flow beneath the tailings. This pipeline, however, was undersized and couldn't handle runoff or snowmelt events and deteriorated over time. In 1982 a 42- inch diameter reinforced concrete pipe (Figure 3) was installed to replace the wood and tile pipe (Figure 4) (Hydrometrics, 1983). The concrete culvert is the main culvert used for connecting Grove Gulch above and below the CMRC. The old wood and tile pipe that was originally routed through the tailings is still currently discharging into Grove Gulch next to the concrete culvert (figure 4). Figure 5 shows the present underground location for both the concrete pipe (shown in red) and the old wood pipe (shown in blue) underneath the CMRC.

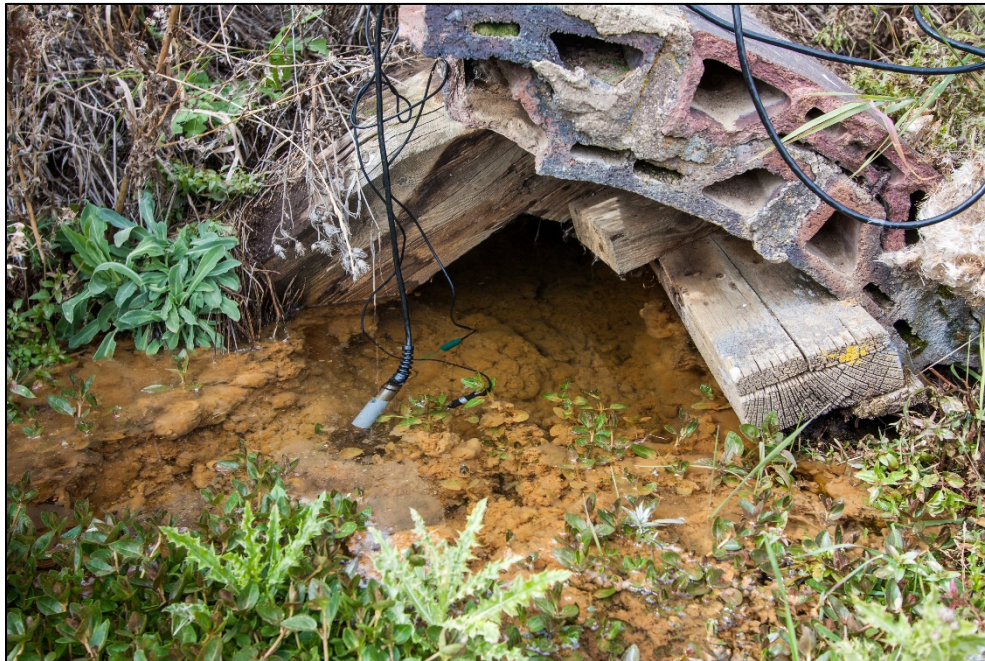
**Figure 4: Original combination vitrified tile and wood stave pipe culvert**

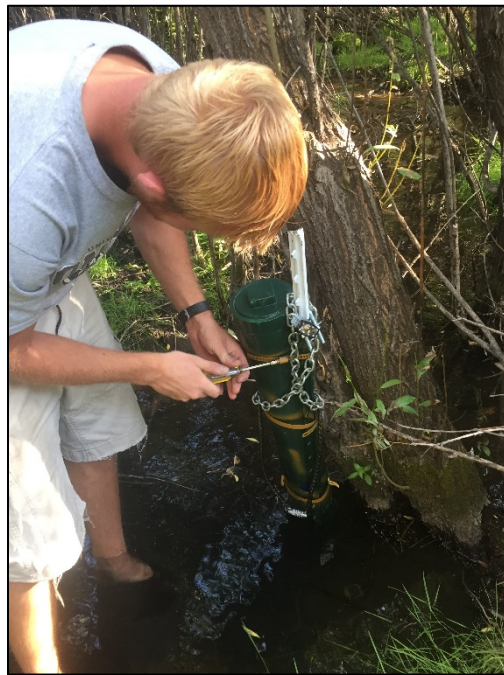
**Figure 9: Upstream sonde location**

were placed in the field from the fall of 2017 to the fall of 2018, with the exception of a three-month period where they were removed because of freezing conditions. The first location, shown in Figure 9, was located south-west and upstream of the CMRC. This location was selected to show water quality characteristics for Grove Gulch above the CMRC. The second Sonde was located at a man-made weir about 650 ft upstream from the confluence of Grove Gulch and BTC. The second location, shown in Figure 10, gathered data for potentially elevated water quality levels of heavy metals in Grove Gulch. These locations were based on historical sampling done prior to this study.

Two YSI EXO<sub>2</sub> multiparameter sondes were used in the field to collect continuous water quality parameter data at two locations on Grove Gulch. YSI sondes can collect high-quality data and are very durable in order to be left out in the field for extended periods of time. The sondes

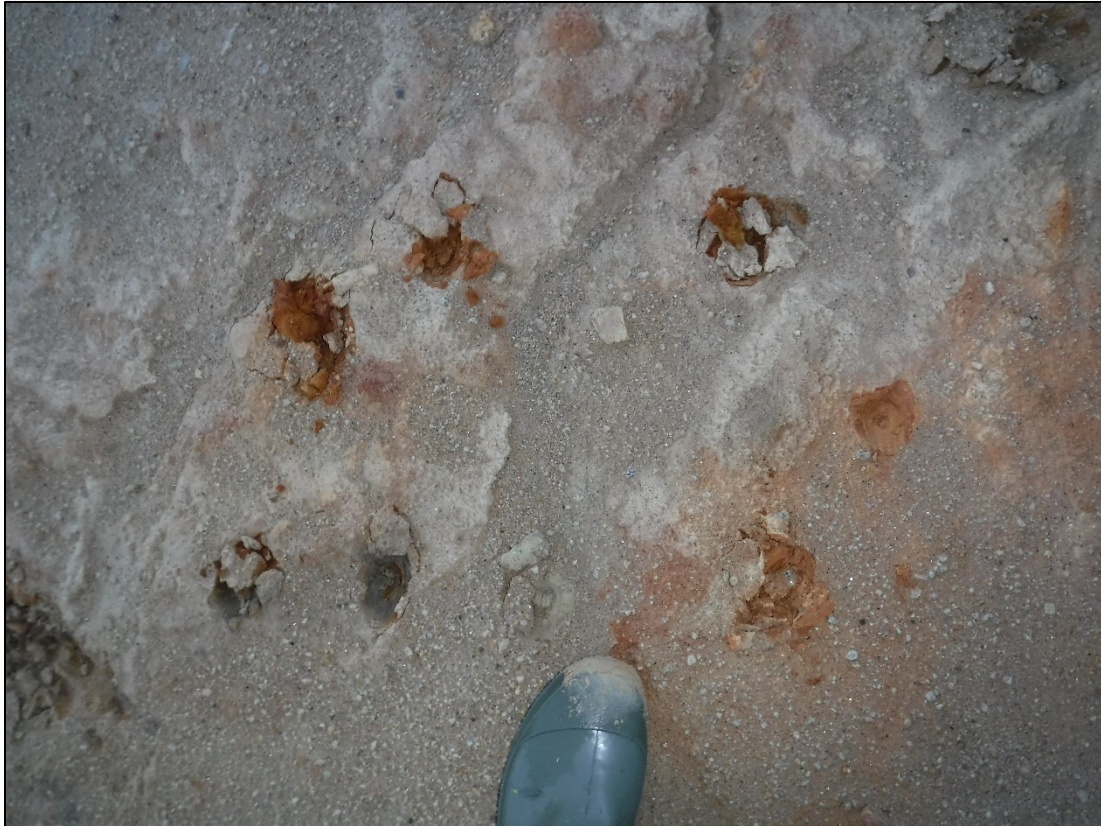
Grove Gulch which observed by sampling overland flow, during a precipitation event, from the direction of the Zinc Mill drainage towards Grove Gulch. This sample contained elevated levels of copper which would exceed water quality standards once discharged into Grove Gulch. The drainage below the Zinc Mill has visible signs of tailings material, coloring of the soil, and minimal vegetation growth (Figure 43).

**Figure 43: Exposed tailings material around the perimeter of the CMRC**
